Manhole Inspection Summary

Manhole # S23G1_004MH

Location Address: **2615 Northshire Dr.**

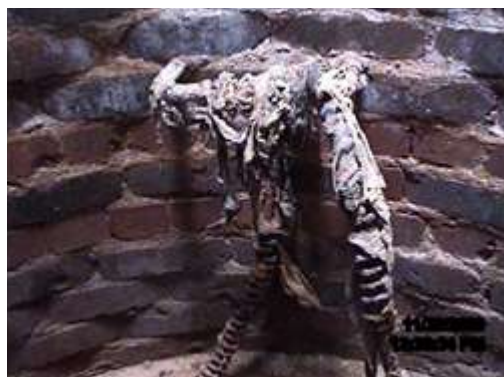
Defect 3

Count: **4** Missing: **0** ☒ Corroded

☒ Evidence Of Surcharge Depth: **1.5** (ft.) ☐ Active Surcharge Present

Surcharge Evidence and Corroded Steps

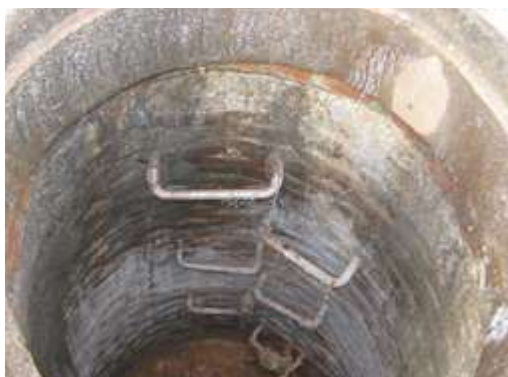
Defect 2

Infiltration: ☐ None ☐ Joint ☐ Cracks ☐ Mortar ☐ Roots ☒ Wall

Corbel infiltration at wall

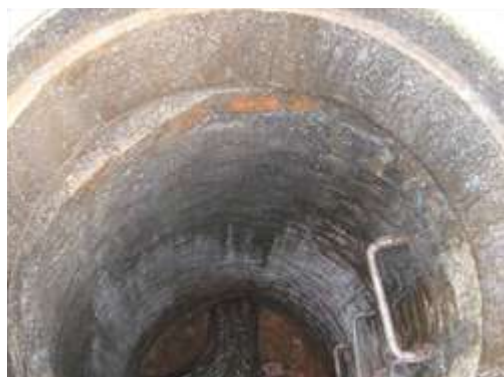
Defect 1

Infiltration: ☐ None ☐ Joint ☐ Cracks ☒ Mortar ☐ Roots ☐ Wall

Chimney Infiltration at mortar

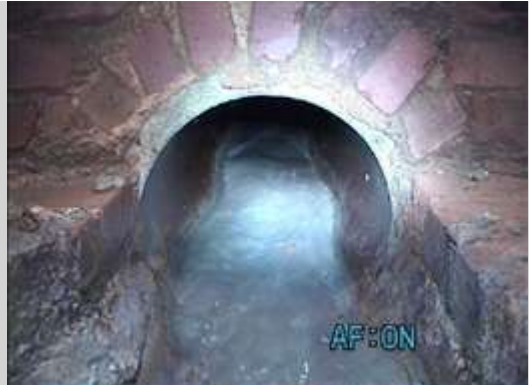
12 O'Clock Outflow

12 in. Circular Gravity Sewer
Pipe Out @ 12 O'Clock

Pipe Height: **12** (in.) Rod and Bar (Angled)
Pipe Material: **Clay** ☐ Pipe Lined
Invert Depth: **11.49** (ft.) Flow Characteristics: **Slow**
Deposits: ☒ None ☐ Mud ☐ Sludge ☐ Debris ☐ Grease
Silt Depth: **0** (in.) Deposits Extent:
Infiltration: **None** Pipe Seal Cond: **Sound**

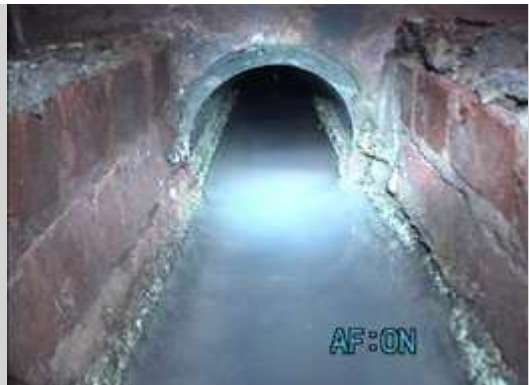
6 O'Clock Inflow

8 in. Circular Gravity Sewer
Pipe In @ 6 O'Clock

Pipe Height: **8.4** (in.) Rod and Bar (Angled)
Pipe Material: **Clay** ☐ Pipe Lined
Invert Depth: **11.44** (ft.) Flow Characteristics: **Slow**
Deposits: ☒ None ☐ Mud ☐ Sludge ☐ Debris ☐ Grease
Silt Depth: **0** (in.) Deposits Extent:
Infiltration: **None** Pipe Seal Cond: **Sound**

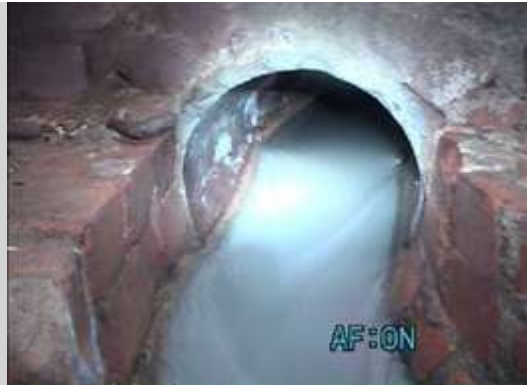
9 O'Clock Inflow

10 in. Circular Gravity Sewer
Pipe In @ 9 O'Clock

Pipe Height: **10.8** (in.) Rod and Bar (Angled)

Infiltration: **None** Pipe Seal Cond: **Sound**
